GEORGETOWN COMMERCIAL ARCHITECTURE - M STREET

Northwest Washington, District of Columbia

Historic American Buildings Survey Selections

February, 1967

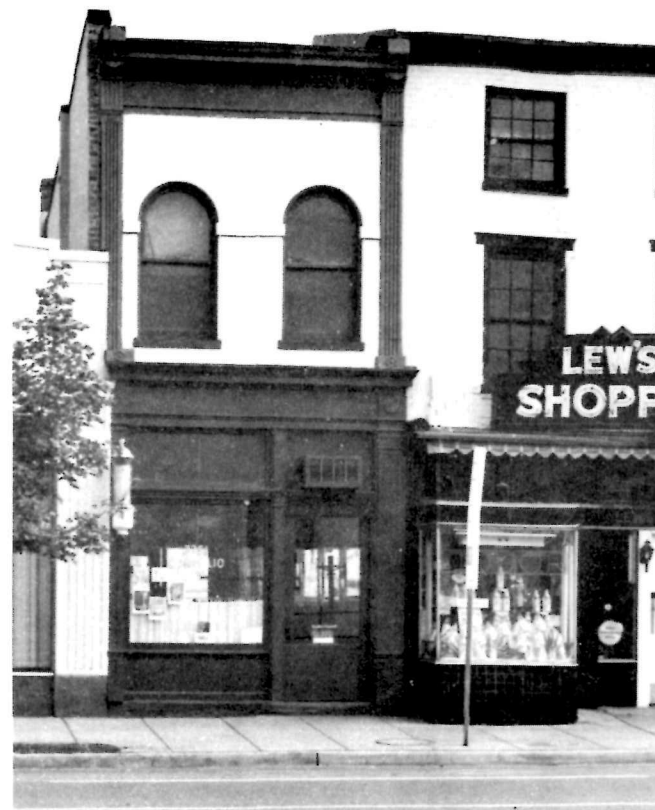
Barber Shop  
3251 M Street

1. Architectural character: This structure, which has no outstanding architectural characteristics or important historical associations, is, nevertheless, typical of the commercial architecture built in Georgetown during the late nineteenth century.
2. Condition of fabric: Fair; structure has been relatively unaltered.

1. Overall dimensions: Approximately 10' (two bays) x 35'; two stories in height.
2. Foundations: Stone foundation extends 8" above grade of public sidewalk on south elevation.
3. Wall construction: Red common bond brick is painted white; sandstone block above foundation spans south (street) facade. Appearance of west wall indicates that structure may have been narrowed to present width at an undetermined date. Projecting brick belt course spans elevation at spring line of second floor window arches.
4. Chimneys: Brick chimney at northwest corner of building.

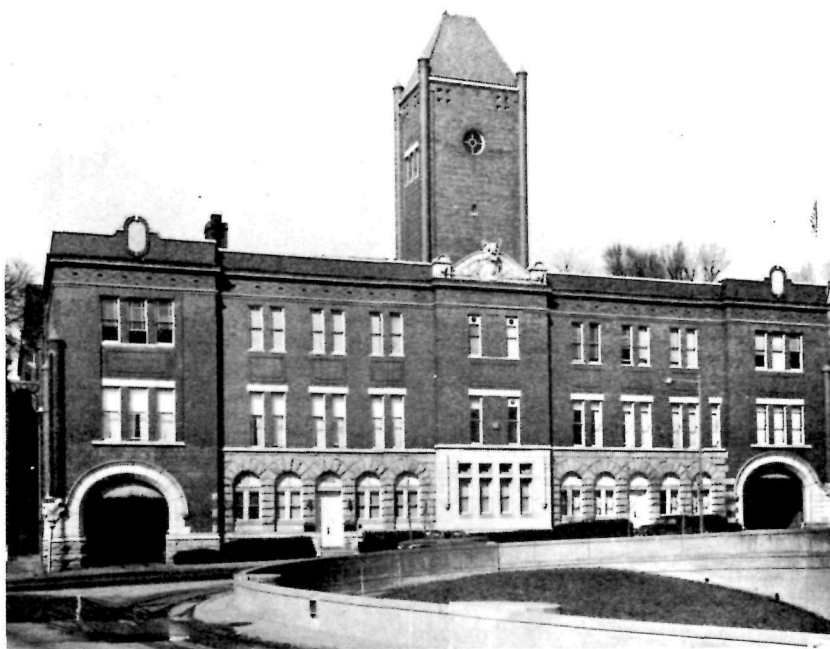
Capital Traction Company Union Station  
3600 M Street

2. Condition of fabric: Excellent, very well-maintained.

1. Overall dimensions: 180' (front) x 242' (deep); three stories in height plus 140' tower.
2. Foundations: Rusticated granite (blue gneiss); retaining wall of concrete under Prospect Street is 13'-9" thick at base, reinforced at 13' to 20' intervals with 4' square brick pilasters.

3. Wall construction: The reddish-purple iron spot brick on 1911 (altered) facade is of common bond with headers every nine courses. Areas of repair over south vehicular doors, while of similar brick is layed in common bond with headers every six courses, may be of later date than 1911. Tower brick is of similar composition, common bond with headers every six courses, dates from original construction. Brick on side (west and east) elevations north of first pavilion areas is smooth red hard-faced and does not match spot brick in color or character. Incised and rusticated stonework is Milford pink granite. Facade was completely altered in major remodeling of 1911, resulting in loss of much of its original strength and vitality.

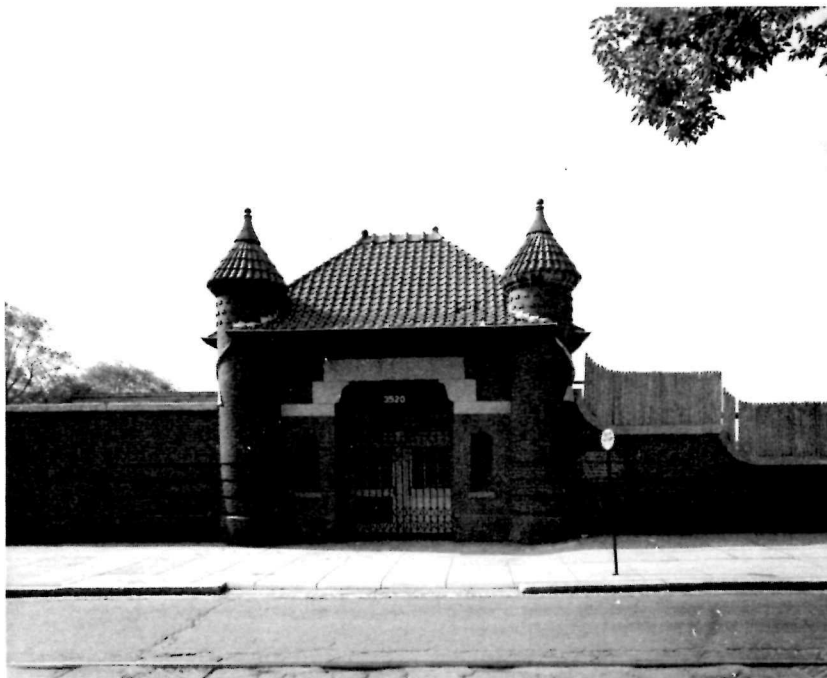
Capital Traction Company Union Station  
Prospect St. Pavilion

- a. Shape, covering: Of original red tiled hipped roof, only portions covering the tower and the Prospect Street pavilion remain. Building is presently covered by a flat built-up roof.
- b. Framing: Framing for the covered walkway constructed with 10" I-beams, the flat roof with 15" and 24" I-beams.
- c. Cornice, eaves; Present terra-cotta cornice and terra-cotta parapet coping are very simple in design. Elaborate broken pediment atop projecting central pavilion has been raised two floors above its original position. Austere cartouche breaks parapet atop each end pavilion. Narrow belt course above upper windows defines, with cornice, area of decorative brickwork from 1911 alteration.
- d. Dormers: Original dormers were removed in alteration of 1911. Corner tourell-like motifs remain, apparently unchanged from original construction.

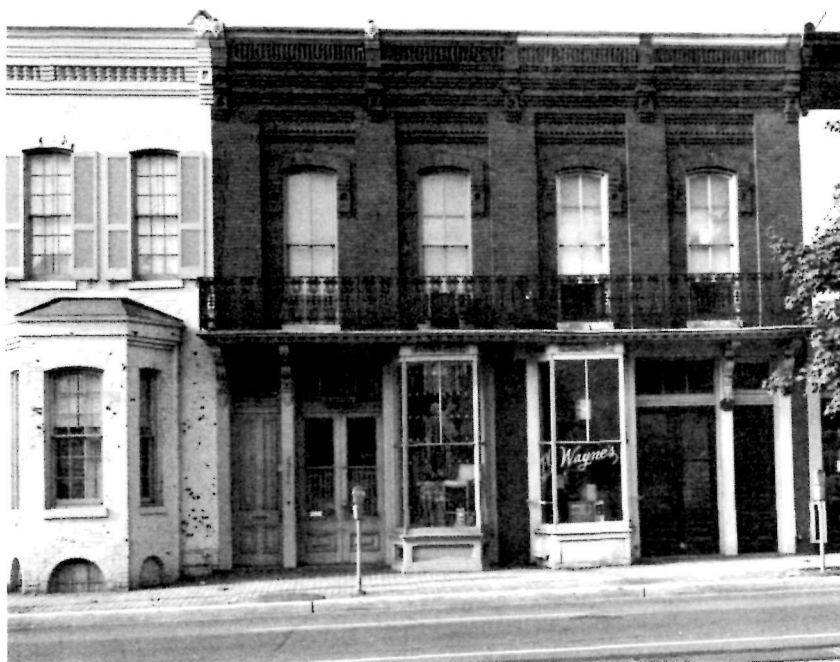
Commercial Building  
2922-2924 M Street

1. Architectural character: A typical Georgetown commercial structure in plan and function, the building is distinctive by virtue of its unusually ponderous and elaborate brick work. The more commonplace shop fronts provide insufficient visual support for the massive effect of the masonry above.
2. Condition of fabric: Good; brick is in excellent condition.

1. Overall dimensions: 32'-6" (four-bays) x approximately 65'; two stories.
2. Foundations: Stone.
3. Wall construction: Brick front is among the most elaborate in the commercial area. Piers of common bond define bays, within which are window apertures. Between piers above windows is decorative belt composed of two corbeled courses above and below diagonally-laid stretchers. Above this, three separate corbeled belts form base for decorative eave brickwork.

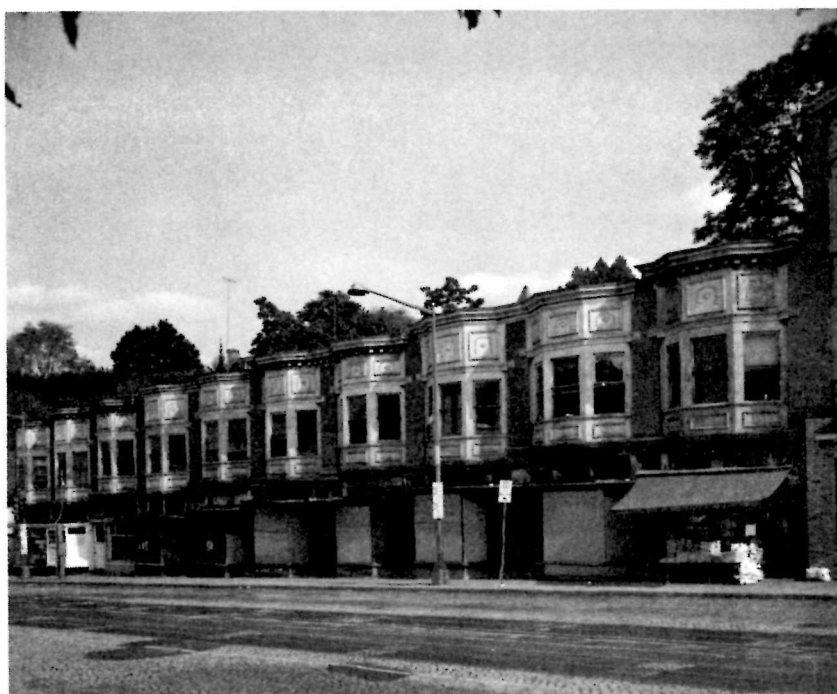
Eynon Building  
3407 M Street

1. Architectural character: The Eynon Building is typical of early 20th century commercial-residential urban row-buildings utilizing stamped metal sheathing combined with wooden and masonry construction.
2. Condition of fabric: Wooden elements and shop bays are in poor condition, brick fabric is in good condition.

1. Overall dimensions: Dimensions across front (south) elevation 180'± Eynon building only, (3407-09 M Street), 29'-7" (front); ten two-story units, (3405-3423 M Street), 150'-0"; two three-story units (3403 M Street), 30'-0". Approximate depth, 50'.
2. Foundations: Stone.
3. Wall construction: The front (south elevation) is composed primarily of shop windows and doorways with bay windows above. Sand colored common bond brick piers between the bay windows occur above voids and therefore appear structurally illogical.

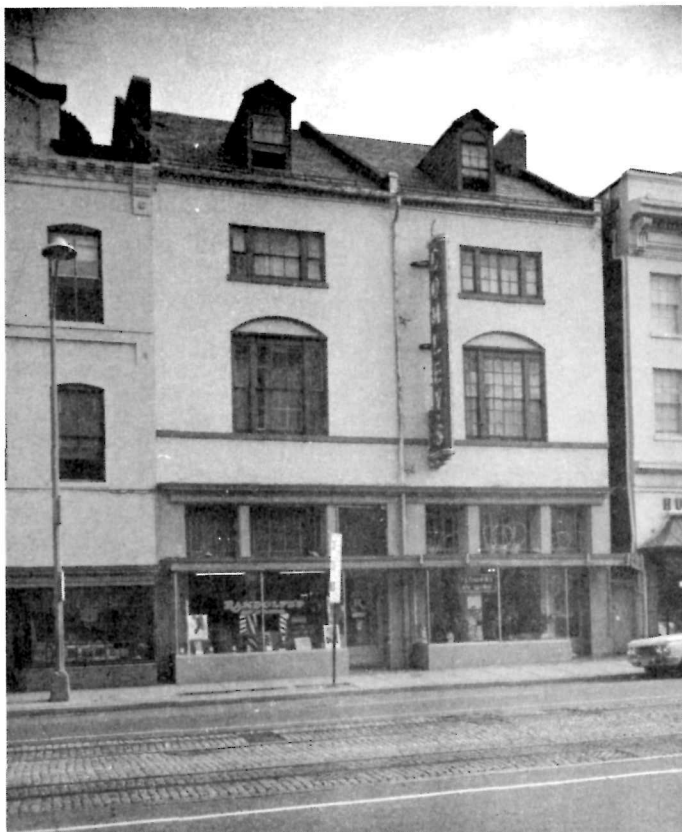
Thomas Cramphin Building  
3209-3211 M Street

1. Architectural character: An early nineteenth-century brick double structure, the Thomas Cramphin Building is noteworthy for its atypical upper fenestration.
2. Condition of fabric: Good.

1. Overall dimensions: 44' (two unusually wide bays) x 60' (to alley, including dock); three-and-one-half stories in height.
2. Foundations: Stone rubble masonry.
3. Wall construction: (South) facade is of Flemish bond, painted very light orange-pink; north elevation is unpainted red brick of common bond with headers every six courses. Stone belt course crosses facade under second-floor windows. Party wall indicated by brick ridge of one course header rowlocks and one course stretchers paralleling gables.
4. Chimneys: Brick chimneys over end walls on each quadrant of gable roof measure 1'-8" x 4'-8"; 6" cement caps bevel inward at top.
5. Openings:
  - a. Doorways and doors: Shop doorways on first floor are comparatively modern. Single-paned wooden

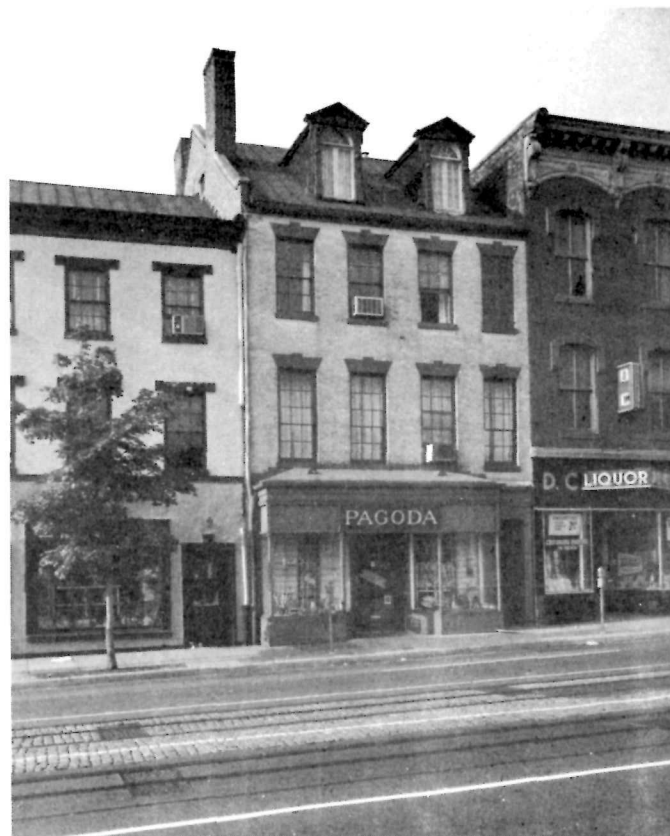
Thomas Robertson House  
3116-3118 M Street

1. Architectural character: An early nineteenth-century commercial and residential structure, the Thomas Robertson House has undergone little exterior alteration above the first floor except for the dormers. The dignified and well-proportioned facade is a simple but characteristic example of the Federal period.
2. Condition of fabric: Good; brick appears to be in very good condition.

2. Foundations: Brick to grade on exterior, stone visible in basement.
3. Wall construction: Red Flemish bond brick has been painted cream on (north) facade. South elevation has been resurfaced in common bond with headers every four courses. East elevation appears to be of common bond with header courses at undetermined intervals.

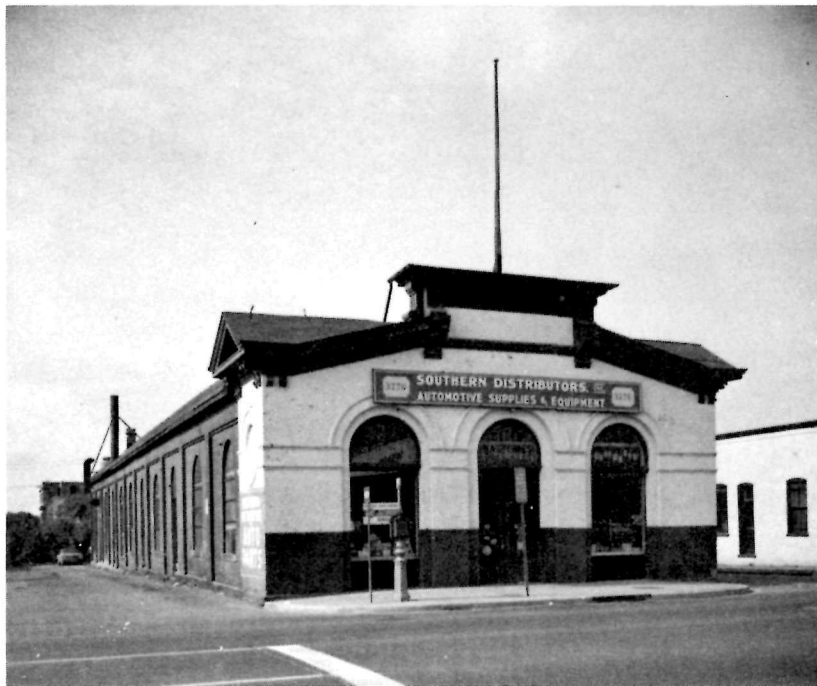
The Georgetown Market  
3276 M Street

1. Architectural character: The Georgetown Market is functional in design and essentially non-derivative in character. Long at the hub of commercial activity in the area, recent proposals to return the market to its originally intended use have revealed widespread and positive interest in this building in Georgetown.
2. Condition of fabric: District Commissioner Tobriner, in a letter to the Honorable John L. McMillan, chairman of the House Committee on the District of Columbia, dated February 8, 1966 [Olszewski, op. cit., pp. 35-36] states in part:

"There is evidence of structural failure in various portions of the foundations walls, running from slight cracking to complete collapse. The first floor joists and auxiliary posts...are thoroughly infested with termites. The flooring is badly worn and holed in many places. The brick exterior walls are in need of repairing generally, and require rebuilding in two areas. The wooden roof structure appears to be generally sound, but much leakage of the roof has caused extensive rotting in the trim and eave boards of the roof. The standing seam tin roof is obviously in need of repair or replacement."

3. Wall construction: Red brick is layed in common bond with headers occurring at intervals of eight courses. Brick pilasters project from wall; supported by foundation stones, they merge into projecting brick "cornice" on sides. Pilasters effectively define bays, within which are round-arched openings.

Estimated cost of renovation including cleaning up and rat-proofing basement, replacement of existing first floor construction with steel, repairing or replacing doors and/or windows as necessary, cleaning up fabric, installation of public sanitary facilities, refrigeration machinery, heater, boiler and electrical system as well as repair roof, gutter and downspouts is \$166,000 [Olszewski, op. cit., p. 37].

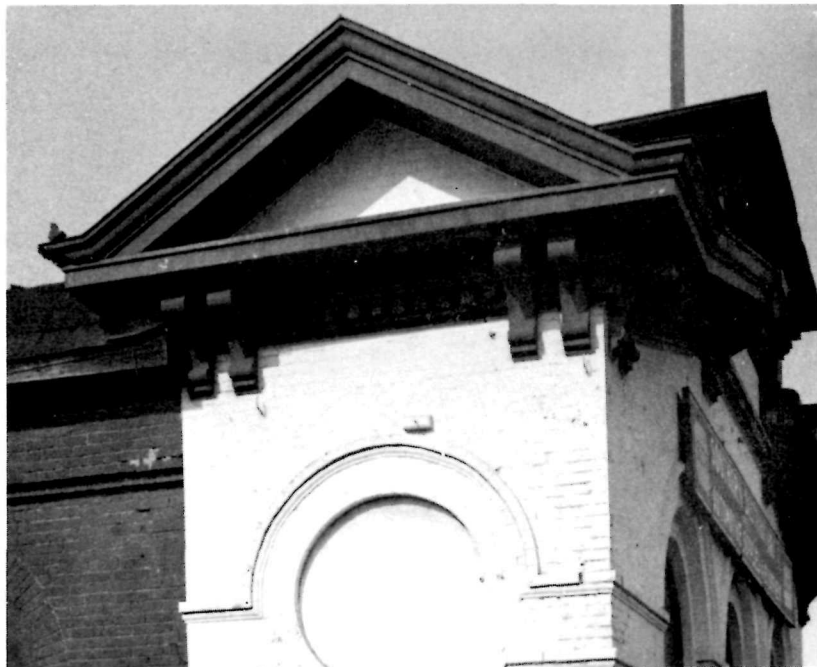
The Georgetown Market  
Cornice Detail

- a. Shape, covering: Very low gable (runs north-south; tin-covered.
- b. Framing: Wood; decking is exposed on (interior) underside.
- c. Cornice, eaves: Elaborate all metal (stamped tin) cornice at north end of Market. Pediments facing east and west are supported by paired brackets at either end. Dentilled and bracketed raking cornices on north front are broken by low central block motif which is capped by flat bracketed and dentilled cornice. Flagpole surmounts block motif.
- d. Dormers: None.
